**Flood Control Project Maintenance  
Levee Inspections**

**Fall 2018 Levee Maintenance Deficiency Summary Report**

**Reclamation District No. 1001 Nicolaus**

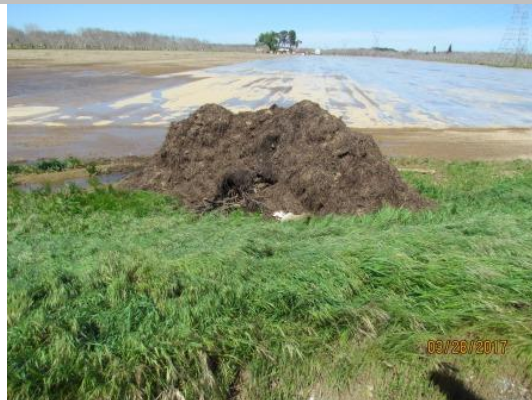
Photo 1 of 1 : FA\_2018\_RD1001\_36\_27\_20180918\_00017.jpg

LM Start	0.51	Rating **	M	Issue No.	27
LM End	0.51	Issue Type +	En	Location *	LS
Category	Earthen Levee			GPS Latitude/Longitude	
				Start	End
Item	Encroachments			38.975308 °	38.975308 °
				-121.476731 °	-121.476731 °
DWR ID	DWR_RD1001_01_s_2017_27				
Comment Code					
PR : Prunings					
Inspector Comment					
Debris/pruning's at landside levee toe.

View of debris/pruning's at landside levee toe, Spring 2017.

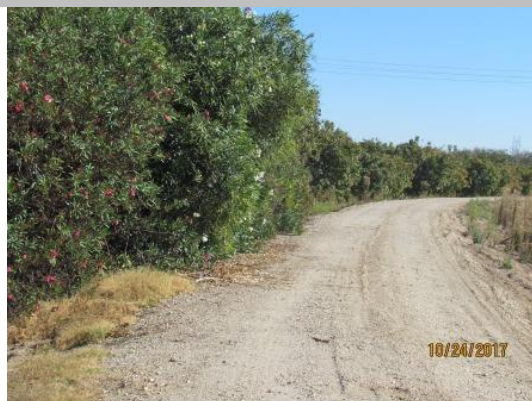
Photo 1 of 1 : FA\_2018\_RD1001\_36\_15\_20180918\_00009.jpg

LM Start	0.95	Rating **	M	Issue No.	15
LM End	0.95	Issue Type +	En	Location *	LS
Category	Earthen Levee			GPS Latitude/Longitude	
				Start	End
Item	Vegetation			38.974569 °	38.974569 °
				-121.484815 °	-121.484815 °
DWR ID	DWR_RD1001_01_s_2012_15				
Comment Code					
V6 : Landscaping					
Inspector Comment					
Landscaping needs to be removed from levee toe.

View of the landscaping on the landside levee slope, Fall 2017.

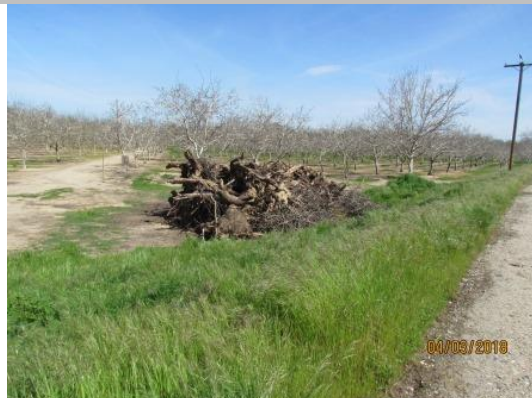
Photo 1 of 1 : FA\_2018\_RD1001\_36\_7\_20180918\_00005.jpg

LM Start	1.29	Rating **	U	Issue No.	7
LM End	1.29	Issue Type +	En	Location *	LS
Category	Earthen Levee			GPS Latitude/Longitude	
				Start	End
Item	Encroachments			38.972655 °	38.972655 °
				-121.490643 °	-121.490643 °
DWR ID	DWR_RD1001_01_f_2014_7				
Comment Code					
PR : Prunings					
Inspector Comment					
Pruning's need to be removed off the levee toe.

This photo was taken of the landside looking upstream at prunings stacked up at the levee toe.

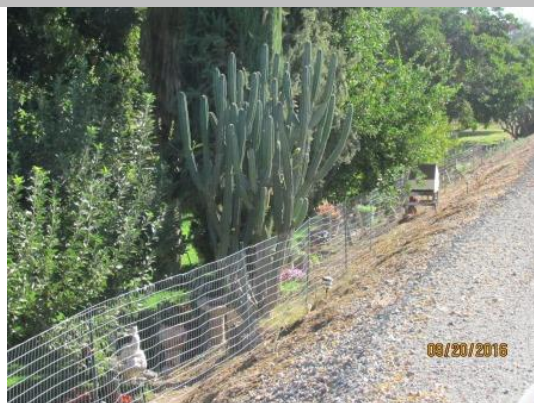
Photo 1 of 1 : FA\_2018\_RD1001\_36\_20\_20180918\_00014.jpg

LM Start	3.13	Rating **	M	Issue No.	20
LM End	3.17	Issue Type +	En	Location *	LS
Category	Earthen Levee			GPS Latitude/Longitude	
				Start	End
Item	Encroachments			38.965663 °	38.965672 °
				-121.521267 °	-121.521919 °
DWR ID	DWR_RD1001_01_f_2016_20				
Comment Code					
FE : Fence					
Inspector Comment					
Land owner has installed an unpermitted fence on the landside levee slope.

View of a fence on the landside levee slope looking upstream.

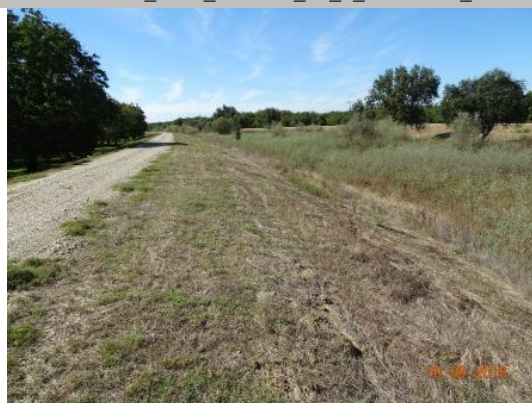
Photo 1 of 1 : FA\_2018\_RD1001\_35\_8\_20181113\_00029.jpg

LM Start	0.00	Rating **	A	Issue No.	8
LM End	3.64	Issue Type +	Ma	Location *	WS
Category	Earthen Levee			GPS Latitude/Longitude	
				Start	End
Item	Vegetation			38.971222°	38.965811°
				-121.474028°	-121.533591°
DWR ID	DWR_RD1001_02_f_2018_8				
Comment Code					
V1 : Control annual grass and weeds on the levee slopes and easements.					
Inspector Comment					
The annual vegetation is well maintained, Fall 2018.

View looking downstream waterside at the well maintained annual vegetation, Fall 2018.

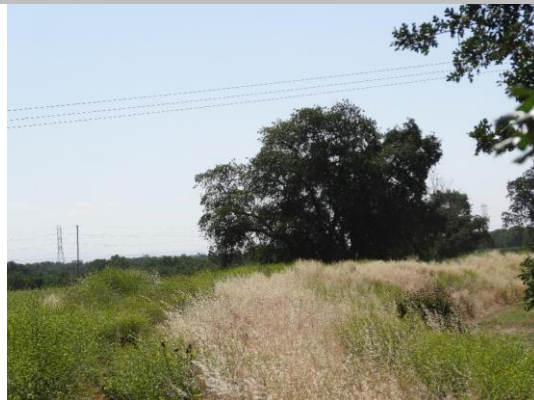
Photo 1 of 3 : UCIP\_FA\_2018\_41673\_22745.jpg

Comment Code						
Inspector Comment						
FS_ID:41673 DS_ID:22536 EP_NO: 5562 Repair Type: Non-Urgent Crossing Status: Found UCIP Comments: 05/23/2013 Pipe appears abandoned and if so should be done so properly. WS pipe plugged with stopper. Seems abandoned. Only abandoned pump base found. (P. Amatya - DWR UCIP) FIELD_STRUCT_DESC: 6-inch coated steel irrigation pipe through the levee, 3.5 feet below the crown. Metal cutoff collar placed on the pipe at the center of the levee crown. Pump was removed. Pump base on the waterside (WS) berm. Shutoff valve on the discharge side of the pump. Foot valve below water on the intake side of the pump. Siphon breaker on the landside (LS) shoulder. Pipe discharges into underground irrigation system on the LS. Power pole and meter box, 10 feet from the landward toe. 1.5-inch flexible conduit through levee, 3.5 feet below the crown. (Pump and irrigation pipe authorized under Permit No. 5562, 1966 - Samuel B. Single). [Additional Reference(s): DWR Levee Log, 1993]. FS Date: 5/23/2013

Levee Crown: dense vegetation on levee crown and sides.

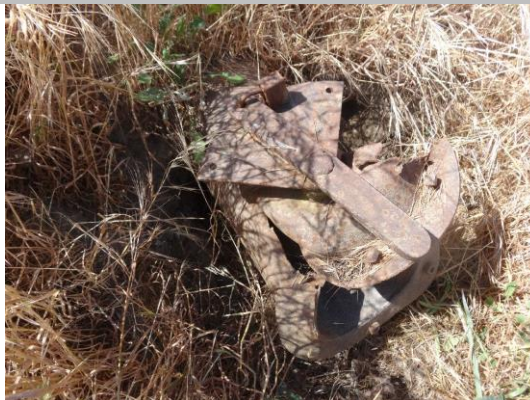
Photo 1 of 3 : UCIP\_FA\_2018\_50740\_22753.jpg

Comment Code						
Inspector Comment						
FS_ID:50740 DS_ID:22529 EP_NO: 2281 Repair Type: Non-Urgent Crossing Status: Not Found UCIP Comments: 07/13/2016 According to district president Joe Henderson, pipe was removed 2-3 years ago. No permit for removal found or evidence of pipe or its removal found. (K. Fazel - UCIP)05/23/2013:- leaky pipe end and erosion on WS.- cracked dirt mound on LS - seems not been used for some time. (P. Amatya - DWR) FIELD_STRUCT_DESC: *REMOVED* 7-inch steel irrigation pipe through the levee, 1.9 feet below the crown. Portable pump mounted on the bank during the summer months. Control valve on the waterside (WS). Steel plate bolted on the WS end during the winter months. Pipe discharges into a 30-inch concrete standpipe at the landside (LS) toe. (Pump and irrigation pipe authorized under Permit No. 2281, 1956 - Willard R. Brown). [Additional Reference(s): DWR Levee Log, 1993]. FS Date: 7/13/2016

WS- end of the pipe.

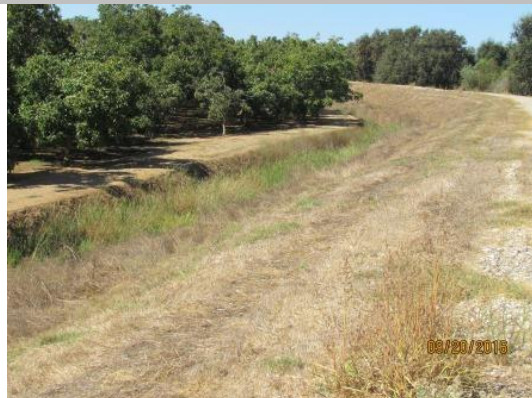
Photo 1 of 1 : FA\_2018\_RD1001\_35\_52\_20180918\_00018.jpg

LM Start	2.28	Rating **	M	Issue No.	52
LM End	2.52	Issue Type +	En	Location *	LS
Category	Earthen Levee			GPS Latitude/Longitude	
				Start	End
Item	Encroachments			38.967402 °	38.967515 °
				-121.510850 °	-121.515270 °
DWR ID	DWR_RD1001_02_s_2012_52				
Comment Code					
DT : Ditch					
Inspector Comment

View of landside irrigation ditch looking downstream.

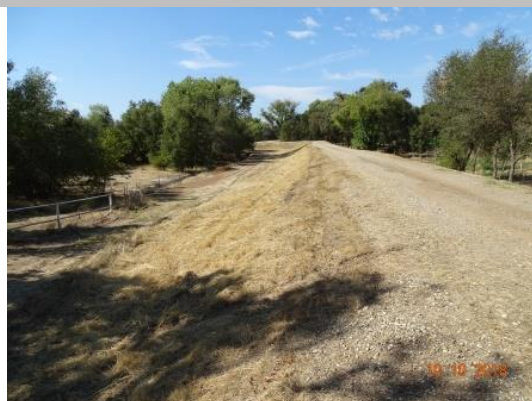
Photo 1 of 1 : FA\_2018\_RD1001\_37\_14\_20181113\_00041.jpg

LM Start	0.01	Rating **	A	Issue No.	14
LM End	12.57	Issue Type +	Ma	Location *	LS
Category	Earthen Levee			GPS Latitude/Longitude	
				Start	End
Item	Vegetation			39.006570 °	38.941182 °
				-121.375115 °	-121.567543 °
DWR ID	DWR_RD1001_03_f_2018_14				
Comment Code					
V1 : Control annual grass and weeds on the levee slopes and easements.					
Inspector Comment					
The annual vegetation is well maintained, Fall 2018.

View looking downstream landside at the well maintained annual vegetation, Fall 2018.

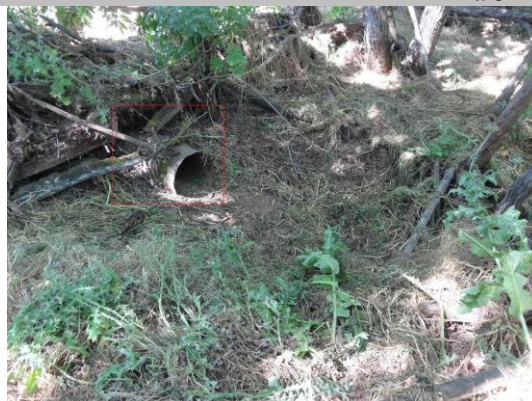
Photo 1 of 3 : UCIP\_FA\_2018\_14128\_23308.jpg

LM Start	0.88	Rating **	M	Issue No.	911
LM End	0.88	Issue Type +	En	Location *	
Category	Supplemental			GPS Latitude/Longitude	
				Start	End
Item	DWR UCIP Field Study			39.006508 °	39.006508 °
				-121.391086 °	-121.391086 °
DWR ID	22549				
Comment Code					
Inspector Comment					
FS_ID:14128					
DS_ID:22549					
EP_NO: 958					
Repair Type: Non-Urgent					
Crossing Status: Found					
UCIP Comments: 05/21/2013 - slide gate on WS not found- needs abandoned properly. (P. Amatya - DWR UCIP)					
FIELD_STRUCT_DESC: *ABANDONED* 24-inch irrigation pipe of an unknown material through the levee, at an unknown depth. Slide gate on the waterside (WS) end. (24-inch irrigation pipe authorized under Permit No. 958, 1944 - Frank B. Lichty and Maggie Lichty).					
FS Date: 5/21/2013

WS- abandoned CMP on berm of the levee.

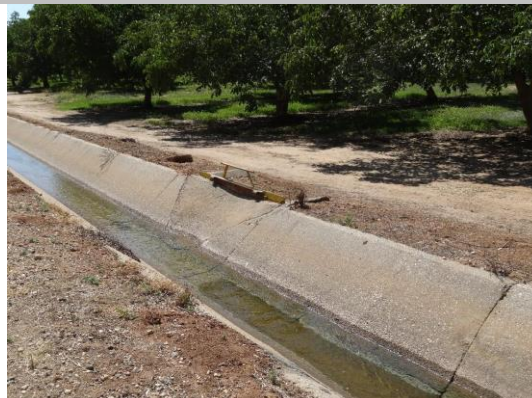
Photo 3 of 3 : UCIP\_FA\_2018\_14128\_23309.jpg

LM Start	0.88	Rating **	M	Issue No.	911 (cont)	
LM End	0.88	Issue Type +	En	Location *		
Category	Supplemental			GPS Latitude/Longitude		
				Start	End	
Item	DWR UCIP Field Study			39.006508 °	39.006508 °	
				-121.391086 °	-121.391086 °	
DWR ID	22549					
Comment Code						
Inspector Comment						
FS_ID:14128						
DS_ID:22549						
EP_NO: 958						
Repair Type: Non-Urgent						
Crossing Status: Found						
UCIP Comments: 05/21/2013 - slide gate on WS not found- needs abandoned properly. (P. Amatya - DWR UCIP)						
FIELD_STRUCT_DESC: *ABANDONED* 24-inch irrigation pipe of an unknown material through the levee, at an unknown depth. Slide gate on the waterside (WS) end. (24-inch irrigation pipe authorized under Permit No. 958, 1944 - Frank B. Lichty and Maggie Lichty).						
FS Date: 5/21/2013

LS- no pipe or structure found on landside.

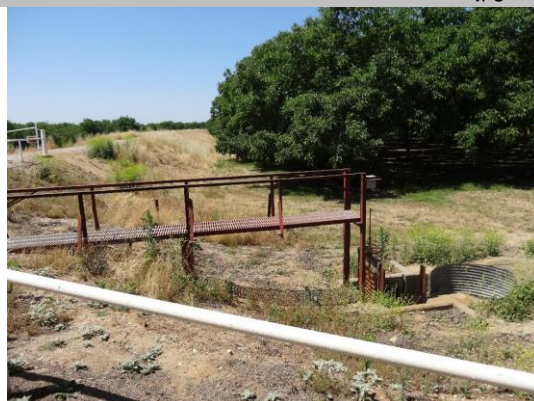
LM Start	<b>1.85</b>	Rating **	M	Issue No.	<b>912 (cont)</b>
LM End	<b>1.85</b>	Issue Type +	En	Location *

WS- steel walkway, CMP and concrete headwall

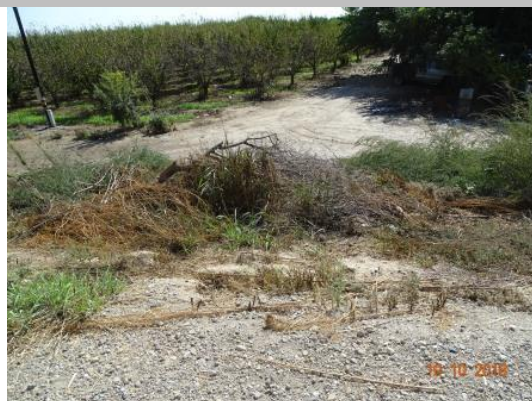
Photo 1 of 1 : FA\_2018\_RD1001\_37\_17\_20181113\_00045.jpg

LM Start	3.46	Rating **	M	Issue No.	17
LM End	3.46	Issue Type +	En	Location *	LS
Category	Earthen Levee			GPS Latitude/Longitude	
				Start	End
Item	Encroachments			38.992021 °	38.992021 °
				-121.433448 °	-121.433448 °
DWR ID	DWR_RD1001_03_f _ 2018_17				
Comment Code					
DE : Debris					
Inspector Comment

View looking at debris and pruning's on the landside levee slope, Fall 2018.

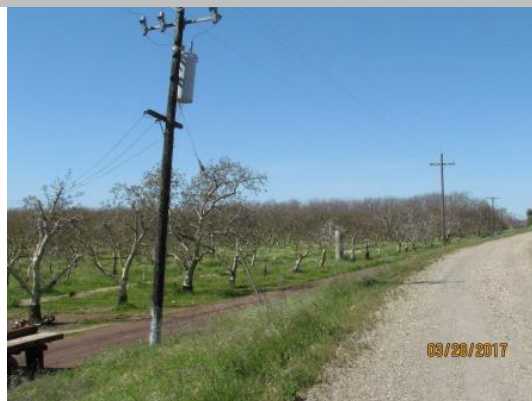
Photo 1 of 1 : FA\_2018\_RD1001\_37\_20\_20180918\_00011.jpg

LM Start	3.61	Rating **	M	Issue No.	20
LM End	3.69	Issue Type +	En	Location *	LS
Category	Earthen Levee			GPS Latitude/Longitude	
				Start	End
Item	Encroachments			38.991230 °	38.991207 °
				-121.435918 °	-121.437433 °
DWR ID	DWR_RD1001_03_f _ 2016_20				
Comment Code					
PO : Pole					
Inspector Comment					
Unpermitted pole line.

View looking downstream of unpermitted pole.

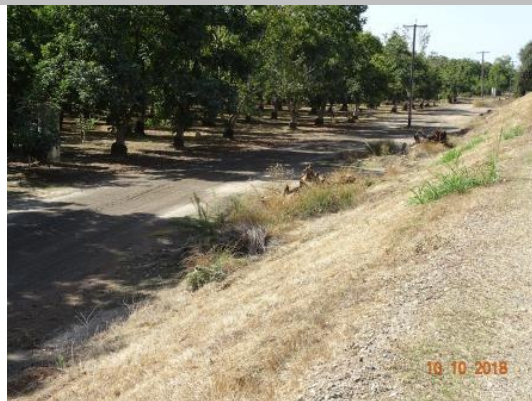
Photo 1 of 1 : FA\_2018\_RD1001\_37\_18\_20181113\_00046.jpg

LM Start	3.78	Rating **	M	Issue No.	18
LM End	3.89	Issue Type +	En	Location *	LS
Category	Earthen Levee			GPS Latitude/Longitude	
				Start	End
Item	Encroachments			38.991220 °	38.991173 °
				-121.439130 °	-121.441249 °
DWR ID	DWR_RD1001_03_f_2018_18				
Comment Code					
PR : Prunings					
Inspector Comment					
Remove stumps from levee toe, Fall 2018.

View looking downstream landside of pushed up stumps at the levee toe, Fall 2018.

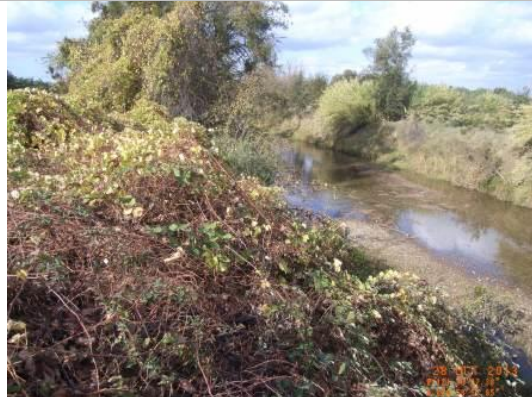
Photo 1 of 1 : FA\_2018\_RD1001\_37\_13\_20181114\_00013.jpg

LM Start	7.22	Rating **	M	Issue No.	13
LM End	7.31	Issue Type +	Ma	Location *	WS
Category	Supplemental			GPS Latitude/Longitude	
				Start	End
Item	2017 USACE Erosion Survey, DRAFT			38.982737 °	38.982572 °
				-121.501144 °	-121.502797 °
DWR ID	DWR_RD1001_03_f_2018_13				
Comment Code					
Inspector Comment					
2017 Site ID: BER 5.7 L					
Status: Eroding					
2017 Field Notes: Minor new erosion observed.					
Site History: 2008 - Sandy/silty banks with rotational slab failures creating near vertical bank with pop-outs due to tree failures. Narrow berm.

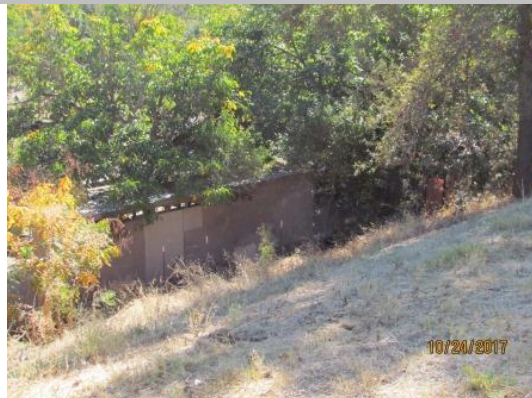
Photo 1 of 1 : FA\_2018\_RD1001\_37\_11\_20180918\_00008.jpg

LM Start	10.49	Rating **	U	Issue No.	11
LM End	10.49	Issue Type +	En	Location *	LS
Category	Earthen Levee			GPS Latitude/Longitude	
				Start	End
Item	Encroachments			38.962770 °	38.962770 °
				-121.545741 °	-121.545741 °
DWR ID	DWR_RD1001_03_f_2015_11				
Comment Code					
BU : Building					
Inspector Comment					
Small sheds are at levee toe, Fall 2017.

View of building at the landside toe.

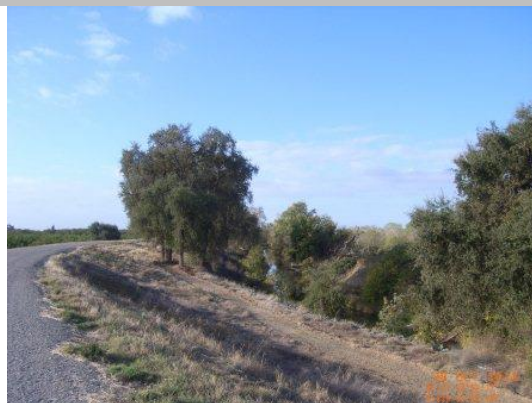
Photo 1 of 1 : FA\_2018\_RD1001\_37\_10\_20181114\_00007.jpg

LM Start	11.08	Rating **	A/W	Issue No.	10
LM End	11.16	Issue Type +	Ma	Location *	WS
Category	Supplemental			GPS Latitude/Longitude	
				Start	End
Item	2017 USACE Erosion Survey, DRAFT			38.955070 °	38.954227 °
				-121.549528 °	-121.550592 °
DWR ID	DWR_RD1001_03_f_2018_10				
Comment Code					
Inspector Comment					
2017 Site ID: BER 1.9 L					
Status: Eroding					
2017 Field Notes: Minor new erosion observed.					
Site History: 2011 - Large slumped sections of bank. 2012 - Slopes slightly steeper.

USACE 2013 Photo #1

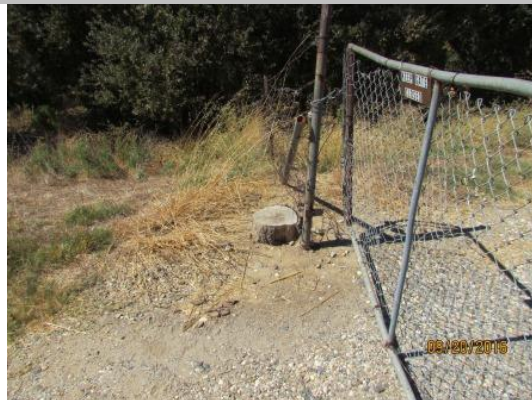
Photo 1 of 1 : FA\_2018\_RD1001\_38\_60\_20180918\_00035.jpg

LM Start	0.55	Rating **	N	Issue No.	60
LM End	0.55	Issue Type +	Ma	Location *	WS
Category	Earthen Levee			GPS Latitude/Longitude	
				Start	End
Item	Trim / Thin Trees			38.933229 °	38.933229 °
				-121.567097 °	-121.567097 °
DWR ID	DWR_RD1001_04_f_2016_60				
Comment Code					
T5 : Tree stumps.					
Inspector Comment

View of tree stump, waterside crown at gate.

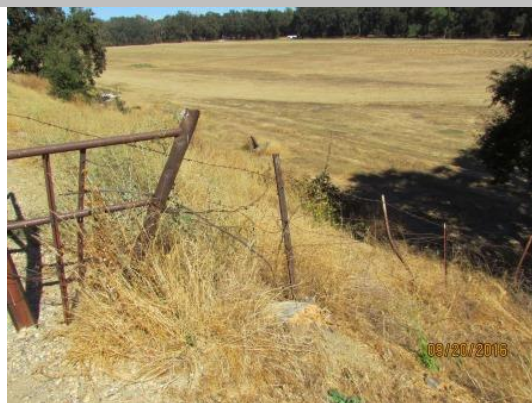
Photo 1 of 1 : FA\_2018\_RD1001\_38\_61\_20180918\_00036.jpg

LM Start	0.55	Rating **	N	Issue No.	61
LM End	0.55	Issue Type +	Ma	Location *	LS
Category	Earthen Levee			GPS Latitude/Longitude	
				Start	End
Item	Trim / Thin Trees			38.933229 °	38.933229 °
				-121.567097 °	-121.567097 °
DWR ID	DWR_RD1001_04_f_2016_61				
Comment Code					
T5 : Tree stumps.					
Inspector Comment

View of tree stump, landside crown at gate.

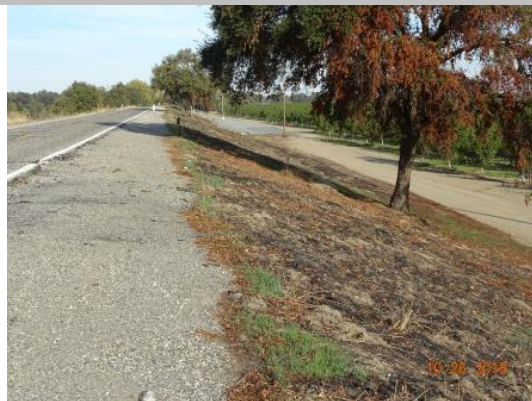
Photo 1 of 2 : FA\_2018\_RD1001\_38\_54\_20181114\_00081.jpg

LM Start	0.57	Rating **	A	Issue No.	54
LM End	12.35	Issue Type +	Ma	Location *	LS
Category	Earthen Levee			GPS Latitude/Longitude	
				Start	End
Item	Vegetation			38.932923 °	38.787132 °
				-121.567105 °	-121.620586 °
DWR ID	DWR_RD1001_04_f_2018_54				
Comment Code					
V1 : Control annual grass and weeds on the levee slopes and easements.					
Inspector Comment					
The annual vegetation is well maintained, Fall 2018.

View looking upstream landside LM 11.93 of the well maintained annual vegetation, Fall 2018.

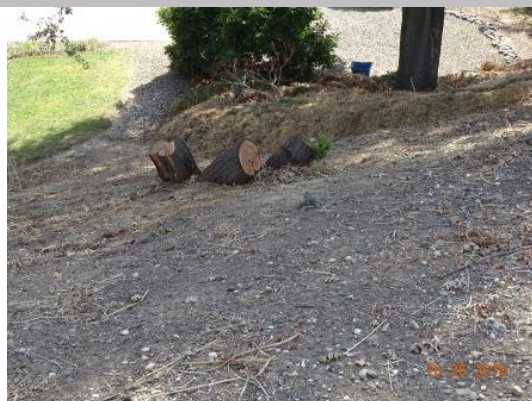
Photo 1 of 1 : FA\_2018\_RD1001\_38\_71\_20181114\_00084.jpg

LM Start	2.44	Rating **	N	Issue No.	71
LM End	2.44	Issue Type +	Ma	Location *	LS
Category	Earthen Levee			GPS Latitude/Longitude	
				Start	End
Item	Trim / Thin Trees			38.907466 °	38.907466 °
				-121.575413 °	-121.575413 °
DWR ID	DWR_RD1001_04_f_2018_71				
Comment Code					
T5 : Tree stumps.					
Inspector Comment					
Stumps should be removed from levee slope, Fall 2018.

View looking landside at stumps from a fallen and removed tree, Fall 2018.

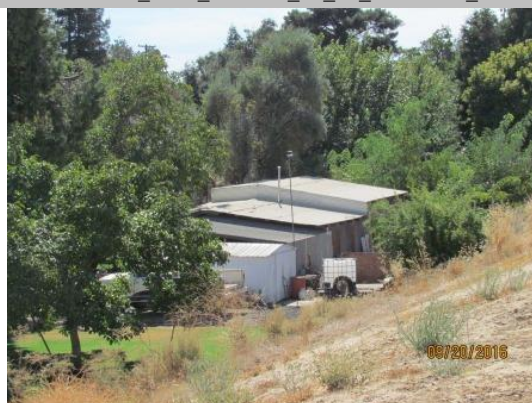
Photo 1 of 1 : FA\_2018\_RD1001\_38\_20\_20180918\_00005.jpg

LM Start	2.59	Rating **	M	Issue No.	20
LM End	2.59	Issue Type +	En	Location *	LS
Category	Earthen Levee			GPS Latitude/Longitude	
				Start	End
Item	Encroachments			38.905773 °	38.905773 °
				-121.577164 °	-121.577164 °
DWR ID	DWR_RD1001_04_s_2013_20				
Comment Code					
BU : Building					
Inspector Comment

View of Buildings along the toe within the easement of the landside levee.

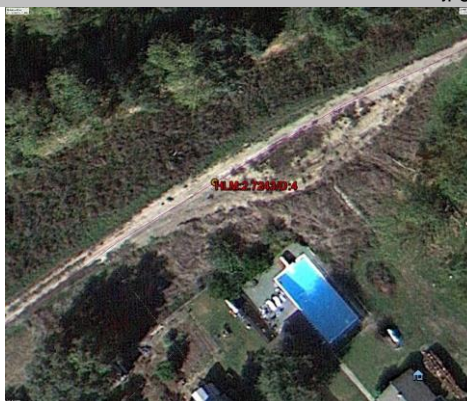
Photo 1 of 1 : UCIP\_FA\_2018\_41987\_24126.jpg

LM Start	2.68	Rating **	M	Issue No.	152	
LM End	2.68	Issue Type +	En	Location *		
Category	Supplemental			GPS Latitude/Longitude		
				Start	End	
Item	DWR UCIP Field Study			38.905089 °	38.905089 °	
				-121.578477 °	-121.578477 °	
DWR ID	22568					
Comment Code						
Inspector Comment						
FS_ID:41987						
DS_ID:22568						
EP_NO: N/A						
Repair Type: Non-Urgent						
Crossing Status: Indicator Found						
UCIP Comments: 05/16/2013 Dense vegetation on slopes should be cleared. (P. Amatya - DWR UCIP)						
FIELD_STRUCT_DESC: 4-inch steel swimming pool drainage pipe through the levee, 3 feet below the crown. Open on the waterside (WS) end. Swimming pool on the landside (LS) toe. (Nate Wise). [Additional Reference(s): DWR Levee Log, 1993].						
FS Date: 5/16/2013

LS- only a private swimming pool found.

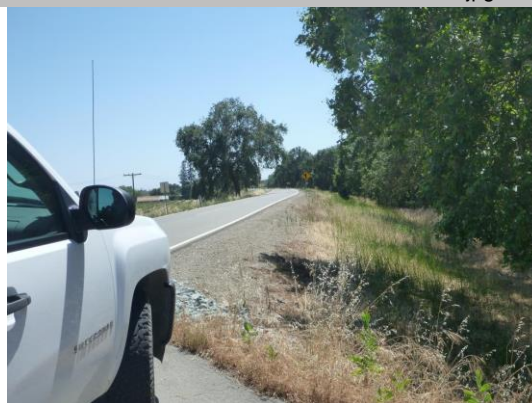
Photo 1 of 3 : LEVAL\_FA\_2018\_139\_1148.jpg

LM Start	5.61	Rating **	A/W	Issue No.	35
LM End		Issue Type +	Ma	Location *	WS
Category	Supplemental			GPS Latitude/Longitude	
				Start	End
Item	2017 Storm Damage			38.876374 °	°
				-121.613425 °	°
DWR ID	DWR_RD1001_04_f_2017_35				
Comment Code					
Inspector Comment					
Levee Evaluation Comments					
Description:					
Site ID No:139					
Site Designation:LMA-19					
Repair Type: Erosion					
Rating:Area of Concern					
Field Date:6/6/2017					
Notes: Several small erosion sites along 2 miles.

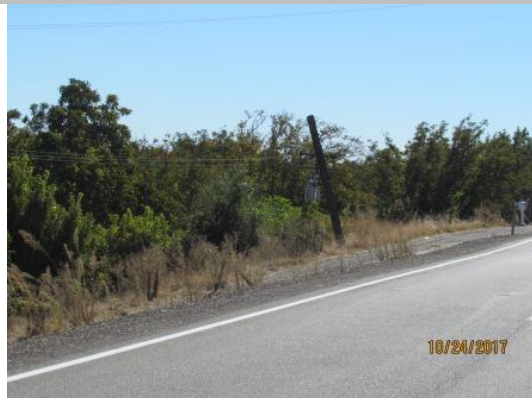
Photo 1 of 1 : FA\_2018\_RD1001\_38\_27\_20180918\_00009.jpg

LM Start	5.71	Rating **	M	Issue No.	27
LM End	5.71	Issue Type +	En	Location *	LS
Category	Earthen Levee			GPS Latitude/Longitude	
				Start	End
Item	Encroachments			38.874984 °	38.874984 °
				-121.614242 °	-121.614242 °
DWR ID	DWR_RD1001_04_s_2015_27				
Comment Code					
PO : Pole					
Inspector Comment					
Remove pole on levee slope, Fall 2018.

View of pole on landside, no lines connected to it.

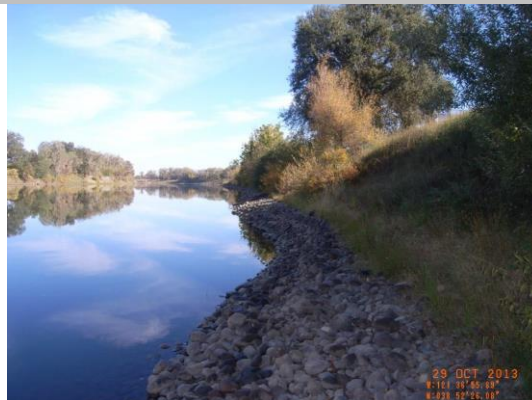
Photo 1 of 1 : FA\_2018\_RD1001\_38\_28\_20181114\_00037.jpg

LM Start	5.80	Rating **	A/W	Issue No.	28
LM End	5.93	Issue Type +	Ma	Location *	WS
Category	Supplemental			GPS Latitude/Longitude	
				Start	End
Item	2017 USACE Erosion Survey, DRAFT			38.874113 °	38.872373 °
				-121.615380 °	-121.616504 °
DWR ID	DWR_RD1001_04_f_2018_28				
Comment Code					
Inspector Comment					
2017 Site ID: FHR 6.6 L					
Status: Eroding					
2017 Field Notes: Sandy bank slope is unraveling.					
Site History: 2011 - Erosion pockets from tree popouts. Sections of the lower bank have slumped off. 2013 - Scallop from tree popouts no longer visible on site. Minor new erosion at the middle of the bank.					
2015 - Fres erosion from human usage.

USACE 2013 Photo #1

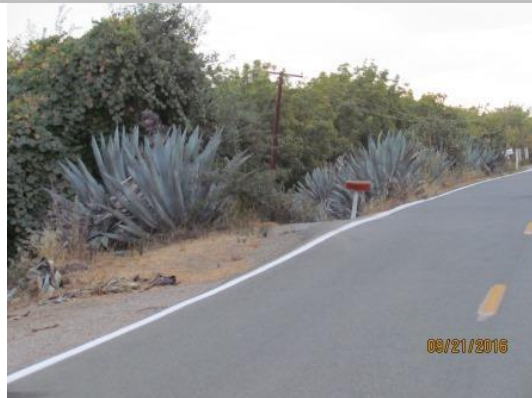
Photo 1 of 1 : FA\_2018\_RD1001\_38\_17\_20180918\_00003.jpg

LM Start	6.39	Rating **	U	Issue No.	17
LM End	6.46	Issue Type +	En	Location *	LS
Category	Earthen Levee			GPS Latitude/Longitude	
				Start	End
Item	Vegetation			38.866032 °	38.865195 °
				-121.619489 °	-121.620017 °
DWR ID	DWR_RD1001_04_s_2012_17				
Comment Code					
V6 : Landscaping					
Inspector Comment					
Home owners landscaping should be removed, Fall 2018.

View of landscaping on the landside shoulder and slope looking downstream.

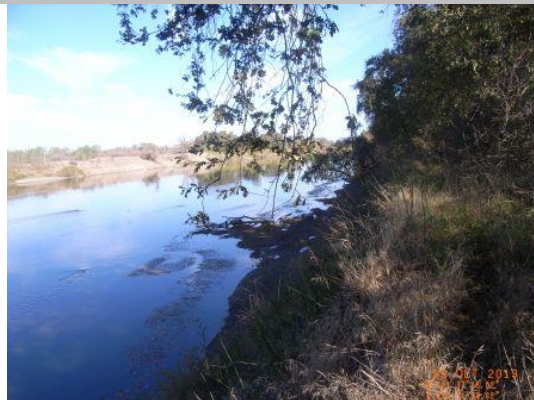
Photo 1 of 1 : FA\_2018\_RD1001\_38\_18\_20181114\_00032.jpg

LM Start	6.42	Rating **	U	Issue No.	18
LM End	6.51	Issue Type +	Ma	Location *	WS
Category	Supplemental			GPS Latitude/Longitude	
				Start	End
Item	2017 USACE Erosion Survey, DRAFT			38.865875 °	38.864706 °
				-121.619983 °	-121.620813 °
DWR ID	DWR_RD1001_04_f_2018_18				
Comment Code					
Inspector Comment					
2017 Site ID: FHR 6.0 L					
Status: Critical					
2017 Field Notes: Upgraded to critical, entire bank slope is slumping, with near vertical face					
Site History: 2011 - Tall slumping sections. Scour around trees has exposed most of the roots. 2016 - Recent large slope failure observed.

USACE 2013 Photo #1

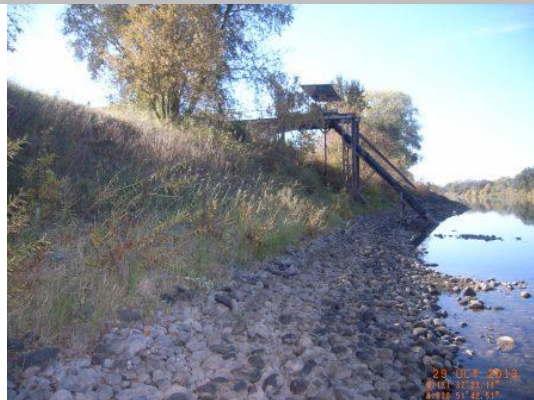
Photo 1 of 1 : FA\_2018\_RD1001\_38\_15\_20181114\_00030.jpg

LM Start	6.57	Rating **	A/W	Issue No.	15
LM End	6.77	Issue Type +	Ma	Location *	WS
Category	Supplemental			GPS Latitude/Longitude	
				Start	End
Item	2017 USACE Erosion Survey, DRAFT			38.863946 °	38.861558 °
				-121.621388 °	-121.623316 °
DWR ID	DWR_RD1001_04_f_2018_15				
Comment Code					
Inspector Comment					
2017 Site ID: FHR 5.8 L					
Status: Eroding					
2017 Field Notes: slope is not stable enough to maintain vegetation growth, new erosion					
Site History: 2011 - Large slumped sections on the lower bank. 2012 - New cracks observed.

USACE 2013 Photo #1

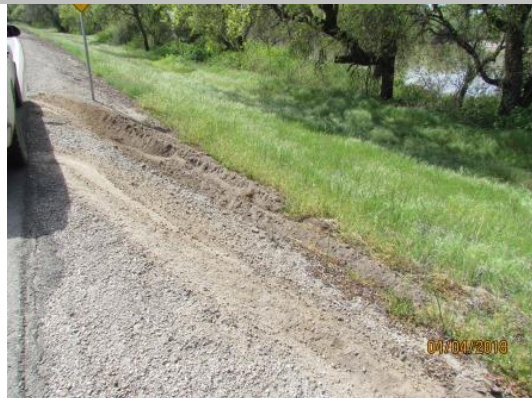
Photo 1 of 1 : FA\_2018\_RD1001\_38\_40\_20180918\_00021.jpg

LM Start	7.06	Rating **	M	Issue No.	40
LM End	7.06	Issue Type +	Ma	Location *	WS
Category	Earthen Levee			GPS Latitude/Longitude	
				Start	End
Item	Slope Stability			38.857797 °	38.857797 °
				-121.625912 °	-121.625912 °
DWR ID	DWR_RD1001_04_s_2018_40				
Comment Code					
S3 : Repair the levee slope damaged by vehicle traffic and prevent access where possible.					
Inspector Comment					
Repair tire ruts on levee slope.

View looking downstream waterside at deep tire ruts in levee slope.

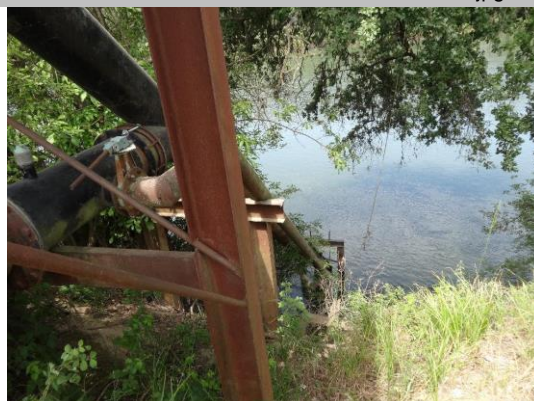
Photo 2 of 3 : UCIP\_FA\_2018\_14563\_24001.jpg

Comment Code						
Inspector Comment						
FS_ID:14563 DS_ID:22577 EP_NO: 12828 Repair Type: Non-Urgent Crossing Status: Found UCIP Comments: 05/16/2013 - needs detailed investigation for road surface cracks (P. Amatya - DWR UCIP) FIELD_STRUCT_DESC: 16-inch asphalt coated steel irrigation discharge pipe through the levee, 4.3 feet below the crown. 30-horsepower slant pump and platform on the riverbank. (16-inch irrigation discharge pipe and 30-horsepower slant pump authorized under Permit No. 12828, 1979. It is assumed that this 16-inch pipe replaces the abandoned 10-inch steel pipe referenced in the O&M Manual). [Additional Reference(s): DWR Levee Log, 1993. USACE Sacramento O&M Manual 141.1, August 1955, (RM 3.3), abandoned 10-inch steel pipe referenced]. FS Date: 5/16/2013

WS- inlet pipe and main pipe in pump station on river bank.

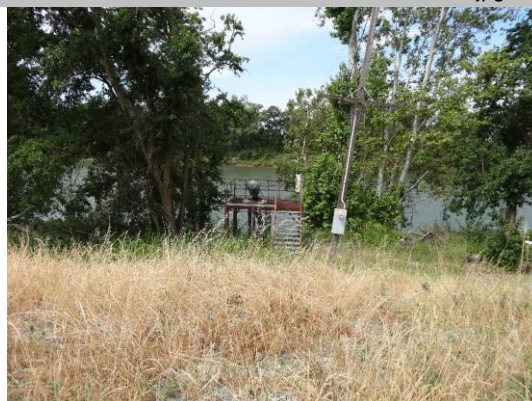
Photo 1 of 3 : UCIP\_FA\_2018\_41723\_23977.jpg

Comment Code						
Inspector Comment						
FS_ID:41723						
DS_ID:22572						
EP_NO: 1881						
Repair Type: Non-Urgent						
Crossing Status: Found						
UCIP Comments: 05/16/2013 - burried slide gate found on WS slope.- concrete box at the landward toe not found. (P. Amatya - DWR UCIP)						
FIELD_STRUCT_DESC: 18-inch steel irrigation discharge pipe through the levee, 5 feet below the crown. Slant pump mounted on a pile structure on the riverbank. Gate valve on the waterside (WS) slope. Siphon breaker on the landside (LS) shoulder. Pipe discharges into a concrete box at the LS toe. (18-inch steel discharge pipe and slant pump authorized under Permit No. 1881, 1954 - L. G. Kipp and R. B. Reith). [Additional Reference(s): DWR Levee Log, 1993].						
FS Date: 5/16/2013

WS- slant pump on steel structure in river bank.

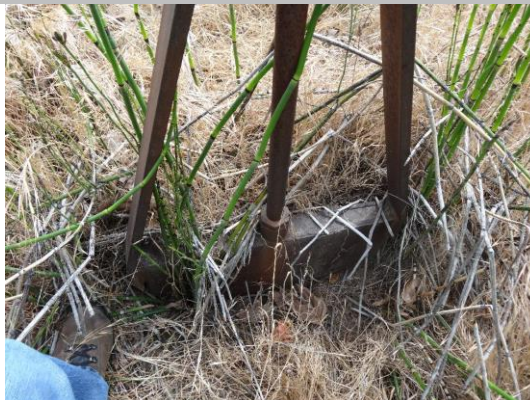
Photo 3 of 3 : UCIP\_FA\_2018\_41723\_23978.jpg

Item	DWR UCIP Field Study			38.815530 °	38.815530 °	
				-121.636918 °	-121.636918 °	
DWR ID	22572					
Comment Code						
Inspector Comment						
FS_ID:41723						
DS_ID:22572						
EP_NO: 1881						
Repair Type: Non-Urgent						
Crossing Status: Found						
UCIP Comments: 05/16/2013 - burried slide gate found on WS slope.- concrete box at the landward toe not found. (P. Amatya - DWR UCIP)						
FIELD_STRUCT_DESC: 18-inch steel irrigation discharge pipe through the levee, 5 feet below the crown. Slant pump mounted on a pile structure on the riverbank. Gate valve on the waterside (WS) slope. Siphon breaker on the landside (LS) shoulder. Pipe discharges into a concrete box at the LS toe. (18-inch steel discharge pipe and slant pump authorized under Permit No. 1881, 1954 - L. G. Kipp and R. B. Reith). [Additional Reference(s): DWR Levee Log, 1993].						
FS Date: 5/16/2013

WS- gate valve on levee slope.

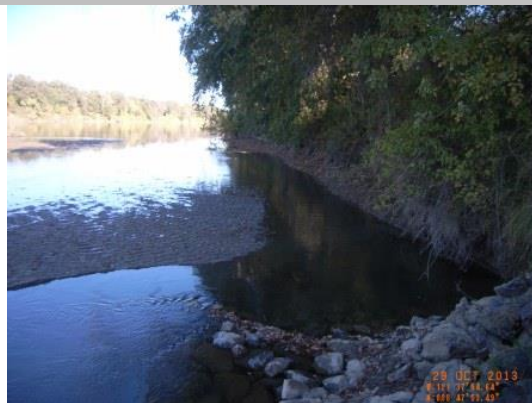
Photo 1 of 1 : FA\_2018\_RD1001\_38\_10\_20181114\_00007.jpg

LM Start	11.18	Rating **	M	Issue No.	10
LM End	11.37	Issue Type +	Ma	Location *	WS
Category	Supplemental			GPS Latitude/Longitude	
				Start	End
Item	2017 USACE Erosion Survey, DRAFT			38.800920°	38.798165°
				-121.633050°	-121.631939°
DWR ID	DWR_RD1001_04_f_2018_10				
Comment Code					
Inspector Comment					
2017 Site ID: FHR 1.0 L					
Status: Eroding					
2017 Field Notes: Significant new erosion along lower bank.					
Site History: 2000 - Site is relatively stable except for some toe erosion at the upstream end, recommend monitoring the upstream end. 2004 - Some new block failures (10ft deep) at the toe of the upstream end.					
2007 - Some minor new slumping at the waterline. 2013 - Minor new erosion along the bank toe.

USACE 2013 Photo #1

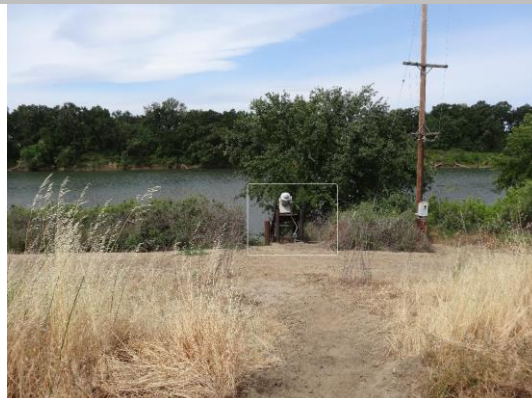
Photo 1 of 3 : UCIP\_FA\_2018\_14548\_23970.jpg

Comment Code						
Inspector Comment						
FS_ID:14548 DS_ID:22580 EP_NO: 3489 Repair Type: Non-Urgent Crossing Status: Found UCIP Comments: 05/16/2013 - siphon breaker on the landward shoulder not found.- cracked road surface along the pipe alienment. Needs more investigations. (P. Amatya - DWR UCIP) FIELD_STRUCT_DESC: 16-inch irrigation discharge pipe of an unknown material through the levee, 3 feet below the crown. 40-horsepower slant pump mounted on a steel structure on the riverbank. Pipe discharges into a 36-inch concrete standpipe at the landside (LS) toe. (Pipe and 40-horsepower pump authorized under Permit No. 3489, 1960 - Kirtland Brothers). [Additional Reference(s): DWR Levee Log, 1993]. FS Date: 5/16/2013

WS- slant pump on river bank.

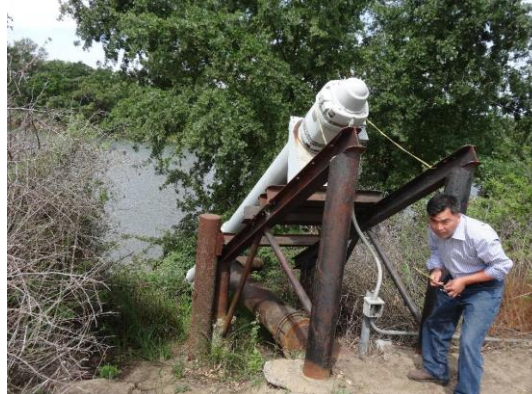
Photo 3 of 3 : UCIP\_FA\_2018\_14548\_23968.jpg

Item	DWR UCIP Field Study			38.799561 °	38.799561 °	
				-121.631964 °	-121.631964 °	
DWR ID	22580					
Comment Code						
Inspector Comment						
FS_ID:14548 DS_ID:22580 EP_NO: 3489 Repair Type: Non-Urgent Crossing Status: Found UCIP Comments: 05/16/2013 - siphon breaker on the landward shoulder not found.- cracked road surface along the pipe alienment. Needs more investigations. (P. Amatya - DWR UCIP) FIELD_STRUCT_DESC: 16-inch irrigation discharge pipe of an unknown material through the levee, 3 feet below the crown. 40-horsepower slant pump mounted on a steel structure on the riverbank. Pipe discharges into a 36-inch concrete standpipe at the landside (LS) toe. (Pipe and 40-horsepower pump authorized under Permit No. 3489, 1960 - Kirtland Brothers). [Additional Reference(s): DWR Levee Log, 1993]. FS Date: 5/16/2013

WS- slant pump, pipe on steel piles.

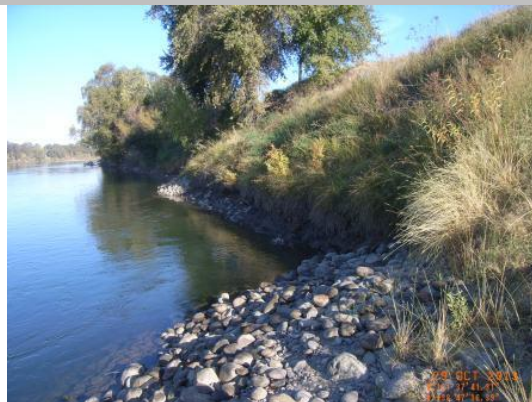
Photo 1 of 1 : FA\_2018\_RD1001\_38\_9\_20181114\_00002.jpg

LM Start	11.59	Rating **	M	Issue No.	9
LM End	11.75	Issue Type +	Ma	Location *	WS
Category	Supplemental			GPS Latitude/Longitude	
				Start	End
Item	2017 USACE Erosion Survey, DRAFT			38.795455 °	38.793394 °
				-121.629903 °	-121.628156 °
DWR ID	DWR_RD1001_04_f _ 2018_9				
Comment Code					
Inspector Comment					
2017 Site ID: FHR 0.6 L					
Status: Eroding					
2017 Field Notes: Further toe erosion, with sections of sand deposition.					
Site History: 1997- Deposits over top of cobble on the upper slope.					
2000 - Old cobble site in poor shape; some toe retreat, but little change; steep bank. 2010 - Site extended upstream due to new toe erosion.					
2012 - Minor new erosion at toe, new slumping, animals holes and cracks observed.

USACE 2013 Photo #1

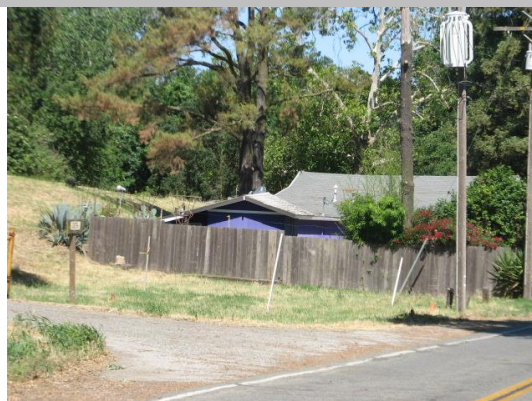
Photo 1 of 1 : FA\_2018\_RD1001\_38\_25\_20180918\_00008.jpg

LM Start	12.48	Rating **	U	Issue No.	25
LM End	12.48	Issue Type +	En	Location *	LS
Category	Earthen Levee			GPS Latitude/Longitude	
				Start	End
Item	Encroachments			38.786073 °	38.786073 °
				-121.618522 °	-121.618522 °
DWR ID	DWR_RD1001_04_s_2012_25				
Comment Code					
BU : Building					
Inspector Comment

An unpermitted building is at the toe of the levee.

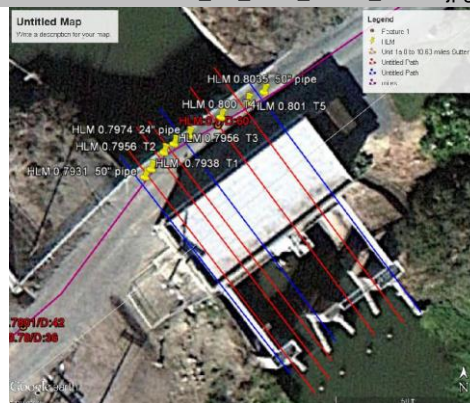
Photo 1 of 3 : UCIP\_FA\_2018\_14393\_23697.jpg

Comment Code						
Inspector Comment						
FS_ID:14393						
DS_ID:22610						
EP_NO: N/A						
Repair Type: Non-Urgent						
Crossing Status: Found						
UCIP Comments: 05/15/2013 - needs repair of concrete piers on waterside. Rebar exposed from the pier. Even though this pier is functionally not linked to the pipe, it needs repair. (P. Amatya - DWR UCIP)						
FIELD_STRUCT_DESC: 5 of 8: 24-inch reinforced concrete drainage discharge pipe through the levee, 25 feet below the crown. Five 60-inch by 84-inch reinforced concrete drainage tunnels through the levee, 25 feet below the crown. One tunnel has a 60-inch pump installed inside and is gated on the waterside (WS) end. Two 50-inch steel drainage discharge pipes through the levee, 25 feet below the crown. All tunnels and pipes are gated. Concrete headwall and railing along the landside (LS). (Reclamation District No. 1001). [Additional Reference(s): DWR Levee Log, 1993].

Location of pipes and tunnels. 24-inch steel pipe located at 5th from the left.

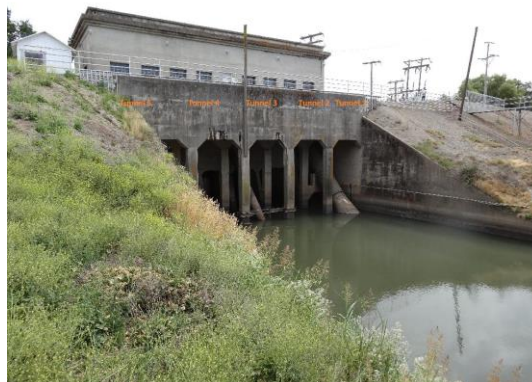
Photo 2 of 3 : UCIP\_FA\_2018\_14393\_23696.jpg

Comment Code						
Inspector Comment						
FS_ID:14393 DS_ID:22610 EP_NO: N/A Repair Type: Non-Urgent Crossing Status: Found UCIP Comments: 05/15/2013 - needs repair of concrete piers on waterside. Rebar exposed from the pier. Even though this pier is functionally not linked to the pipe, it needs repair. (P. Amatya - DWR UCIP) FIELD_STRUCT_DESC: 5 of 8: 24-inch reinforced concrete drainage discharge pipe through the levee, 25 feet below the crown. Five 60-inch by 84-inch reinforced concrete drainage tunnels through the levee, 25 feet below the crown. One tunnel has a 60-inch pump installed inside and is gated on the waterside (WS) end. Two 50-inch steel drainage discharge pipes through the levee, 25 feet below the crown. All tunnels and pipes are gated. Concrete headwall and railing along the landside (LS). (Reclamation District No. 1001). [Additional Reference(s): DWR Levee Log, 1993]. FS Date: 5/15/2013

LS- Drainage structure with tunnels, pipes and pump house. Tunnel 1 at far right and tunnel 5 at far left. The pipe is located inside tunnel 3.

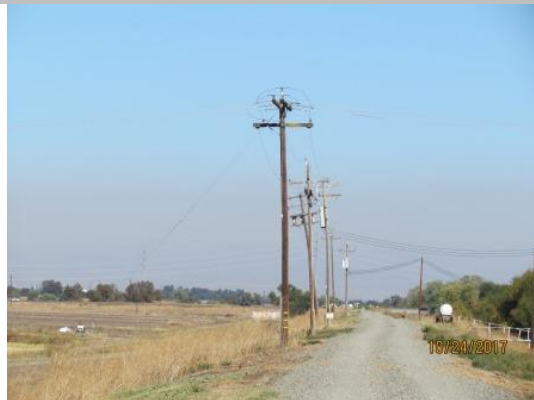
Photo 1 of 1 : FA\_2018\_RD1001\_39\_7\_20180918\_00001.jpg

LM Start	3.56	Rating **	M	Issue No.	7
LM End	3.81	Issue Type +	En	Location *	LS
Category	Earthen Levee			GPS Latitude/Longitude	
				Start	End
Item	Encroachments			38.814919 °	38.817178 °
				-121.556712 °	-121.552965 °
DWR ID	DWR_RD1001_05_s_2012_7				
Comment Code					
PO : Pole					
Inspector Comment

View of poles on the landside shoulder looking downstream.

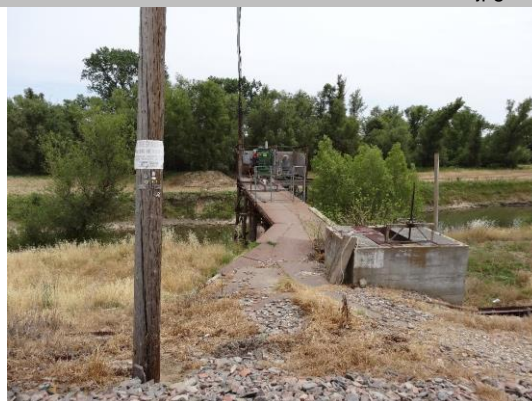
Photo 1 of 3 : UCIP\_FA\_2018\_14472\_23891.jpg

WS- pump station, walkway, and slide gate in concrete box on levee toe

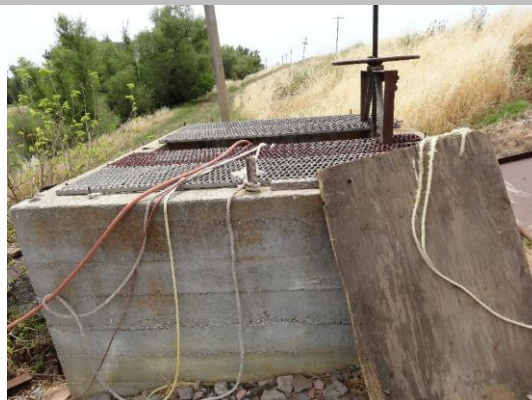
Photo 2 of 3 : UCIP\_FA\_2018\_14472\_23890.jpg

WS- slide gate in concrete box on levee toe

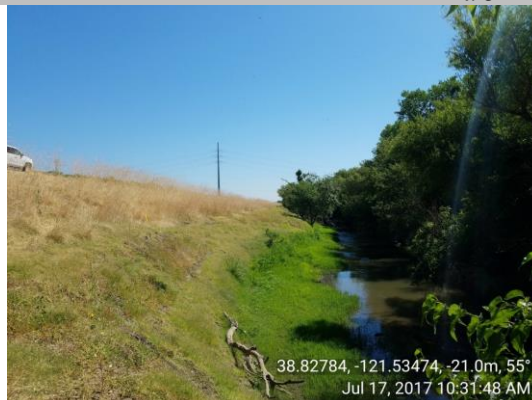
Photo 1 of 3 : LEVAL\_FA\_2018\_493\_1759.jpg

LM Start	5.05	Rating **	A/W	Issue No.	8
LM End	5.06	Issue Type +	Ma	Location *	
Category	Supplemental			GPS Latitude/Longitude	
				Start	End
Item	2017 Storm Damage			38.828100 °	38.828188 °
				-121.534740 °	-121.534625 °
DWR ID	DWR_RD1001_05_f_2017_8				
Comment Code					
Inspector Comment					
Levee Evaluation Comments					
Description:					
Site ID No:493					
Site Designation:RD 1001-03					
Repair Type: Erosion					
Rating:Serious					
Field Date:7/17/2017					
Notes: Serious per senior review

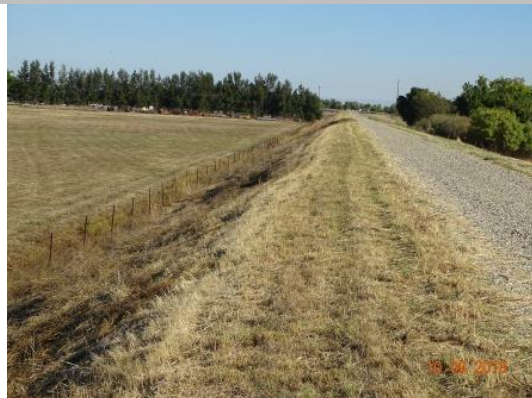
Photo 1 of 1 : FA\_2018\_RD1001\_40\_13\_20181114\_00036.jpg

LM Start	0.00	Rating **	A	Issue No.	13
LM End	4.73	Issue Type +	Ma	Location *	LS
Category	Earthen Levee			GPS Latitude/Longitude	
				Start	End
Item	Vegetation			38.831102°	38.896349°
				-121.529733°	-121.520442°
DWR ID	DWR_RD1001_06_f_2018_13				
Comment Code					
V1 : Control annual grass and weeds on the levee slopes and easements.					
Inspector Comment					
The annual vegetation is well maintained, Fall 2018.

View looking upstream landside at the well maintained annual vegetation, Fall 2018.

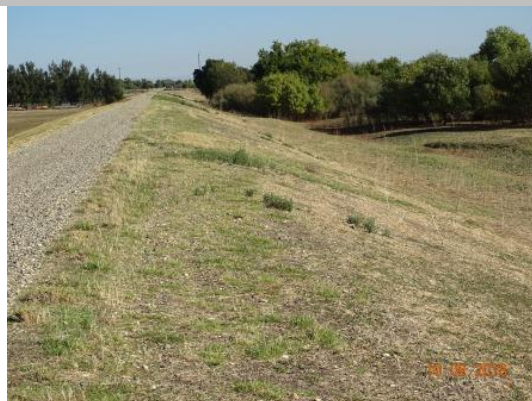
Photo 1 of 1 : FA\_2018\_RD1001\_40\_14\_20181114\_00037.jpg

LM Start	0.00	Rating **	A	Issue No.	14
LM End	4.73	Issue Type +	Ma	Location *	WS
Category	Earthen Levee			GPS Latitude/Longitude	
				Start	End
Item	Vegetation			38.831102 °	38.896349 °
				-121.529733 °	-121.520441 °
DWR ID	DWR_RD1001_06_f_2018_14				
Comment Code					
V1 : Control annual grass and weeds on the levee slopes and easements.					
Inspector Comment					
The annual vegetation is well maintained, Fall 2018.

View looking upstream waterside at the well maintained annual vegetation, Fall 2018.

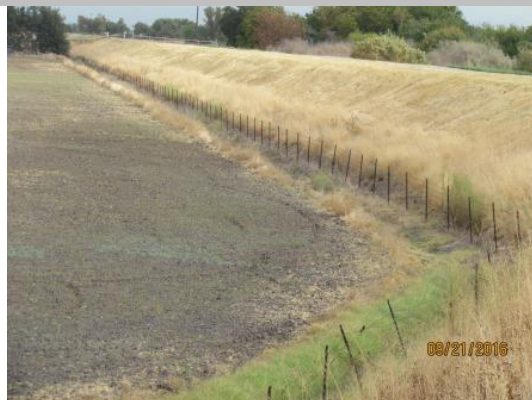
Photo 1 of 1 : FA\_2018\_RD1001\_40\_20\_20180918\_00006.jpg

LM Start	0.02	Rating **	M	Issue No.	20
LM End	0.43	Issue Type +	En	Location *	LS
Category	Earthen Levee			GPS Latitude/Longitude	
				Start	End
Item	Encroachments			38.831243 °	38.836832 °
				-121.529519 °	-121.526810 °
DWR ID	DWR_RD1001_06_f_2016_20				
Comment Code					
FE : Fence					
Inspector Comment					
Fence along the landside levee toe.

View of fence along the landside levee toe looking upstream.

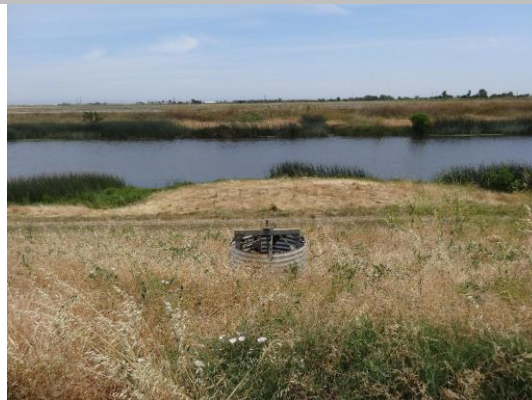
Photo 1 of 3 : UCIP\_FA\_2018\_14244\_23467.jpg

WS- slide gate in CMP riser on levee slope.

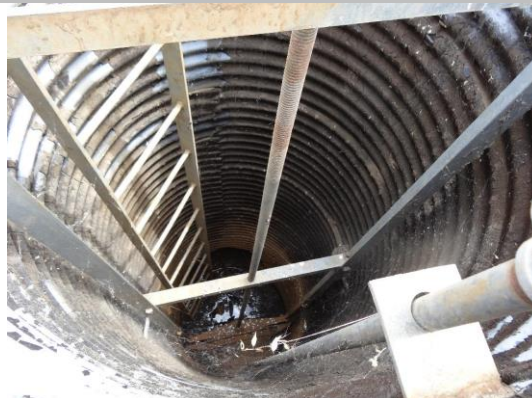
Photo 2 of 3 : UCIP\_FA\_2018\_14244\_23466.jpg

WS- slide gate, air vent pipe in CMP riser on levee slope.

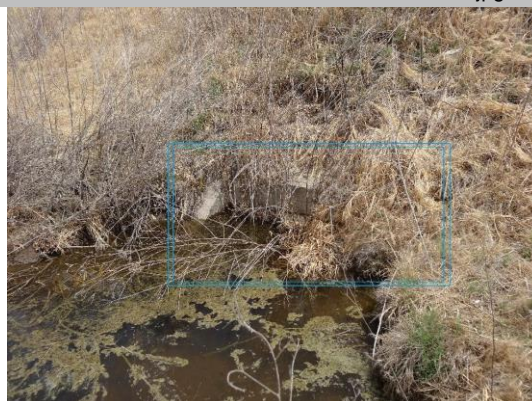
Photo 2 of 3 : UCIP\_FA\_2018\_14223\_23444.jpg

LS- concrete wing wall on levee toe

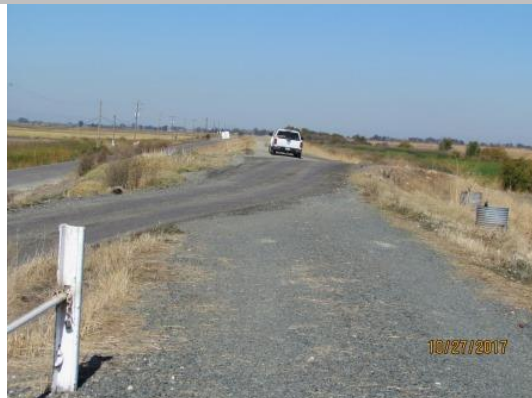
Photo 1 of 1 : FA\_2018\_RD1001\_40\_8\_20180918\_00003.jpg

LM Start	2.05	Rating **	A/W	Issue No.	8
LM End	2.05	Issue Type +	Ma	Location *	CR
Category	Earthen Levee			GPS Latitude/Longitude	
				Start	End
Item	Crown Surface / Depressions / Rutting			38.860002 °	38.860002 °
				-121.524873 °	-121.524873 °
DWR ID	DWR_RD1001_06_s_2012_8				
Comment Code					
C2 : Repair depressions or ruts in the crown or slope.					
Inspector Comment					
Crown where there is cross traffic. Monitor this area and fix as needed.

View of crown where there is cross traffic looking upstream. Monitor this area and fix as needed.

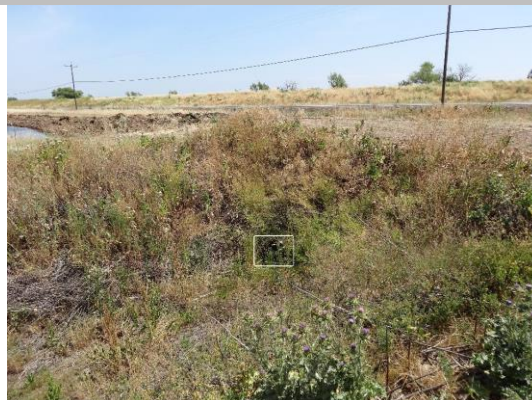
Photo 2 of 3 : UCIP\_FA\_2018\_14167\_23395.jpg

LS- CMP opens in irrigation ditch.

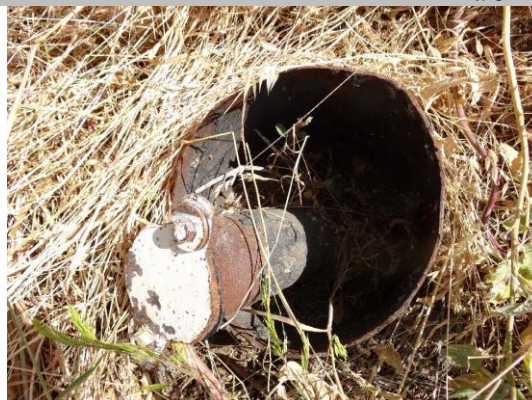
Photo 1 of 2 : UCIP\_FA\_2018\_13523\_22121.jpg

LM Start	3.43	Rating **	M	Issue No.	52	
LM End	3.43	Issue Type +	En	Location *		
Category	Supplemental			GPS Latitude/Longitude		
				Start	End	
Item	DWR UCIP Field Study			38.879960 °	38.879960 °	
				-121.524780 °	-121.524780 °	
DWR ID	22619					
Comment Code						
Inspector Comment						
FS_ID:13523						
DS_ID:22619						
EP_NO: N/A						
Repair Type: Non-Urgent						
Crossing Status: Found						
UCIP Comments: 05/15/2013 - needs filling/plugging gap between 4-inch and 10-inch pipes. (P. Amatya - DWR UCIP)						
FIELD_STRUCT_DESC: 1 of 2: Capped 4-inch steel irrigation pipe sleeved through a 10-inch steel pipe, at an unknown depth. Pipe exposed just off the top of the waterside (WS) slope. [Additional Reference(s): DWR Levee Log, 1993].						
FS Date: 5/15/2013

WS- a 4-inch steel pipe sleeved through 10-inch steel pipe.

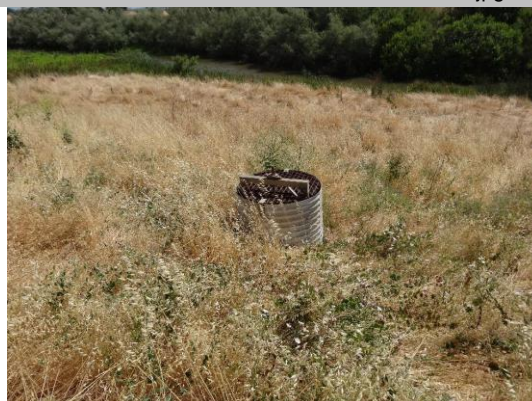
Photo 1 of 3 : UCIP\_FA\_2018\_53425\_22046.jpg

UCIP Comments: 10/30/2018 Photos of the pipe failure, visible from the LS inlet, were uploaded. Crossing remains Urgent due to the deteriorated condition of the pipe. Recommend internal inspection through the levee. (O. Magana - DWR UCIP)10/18/2018 Unable to access the LS toe due to muddy conditions. Assume no repairs have been done to this crossing to date. This crossing is part of DWR's Deferred Maintenance Project (DMP). Based on the photos taken in 2013 and 2016 the pipe section through the wall has missing pipe sections due to heavy corrosion. Recommend repair to avoid further deterioration of pipe section through levee. Levee is about 8-10 feet high. Crossing remains Urgent based on the deteriorated condition of the pipe on the LS. (O. Magana - DWR UCIP)07/13/2016 Same condition as last. Pipe heavily corroded and partially filled with debris and straw. (K. Fazel - UCIP) 05/15/2013:- mud/soil debris on LS pipe end.- highly corroded pipe in outlet.- may require video inspection or pressure test. (P. Amatya - DWR)

WS- slide gate, air vent in CMP riser on levee slope

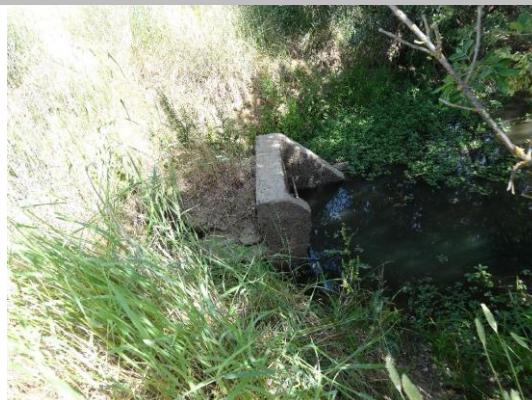
Photo 2 of 3 : UCIP\_FA\_2018\_41724\_22033.jpg

WS- inlet wing wall with trashrack

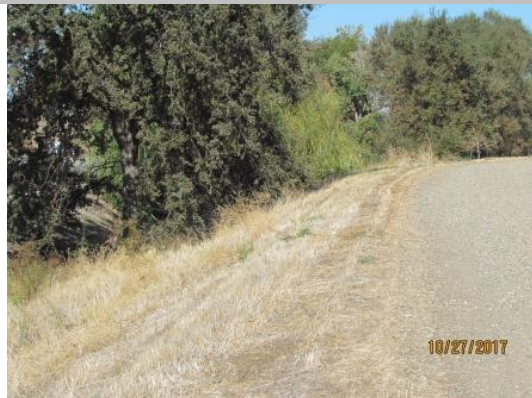
Photo 1 of 1 : FA\_2018\_RD1001\_40\_17\_20180918\_00004.jpg

LM Start	4.48	Rating **	M	Issue No.	17
LM End	4.48	Issue Type +	Ma	Location *	LS
Category	Earthen Levee			GPS Latitude/Longitude	
				Start	End
Item	Trim / Thin Trees			38.895234 °	38.895234 °
				-121.524514 °	-121.524514 °
DWR ID	DWR_RD1001_06_f_2017_17				
Comment Code					
T1 : Trim trees to at least five feet above ground level.					
Inspector Comment					
Trim tree limbs for access and visibility, Fall 2018.

View looking upstream landside at trees that need to be trimmed for access and visibility.

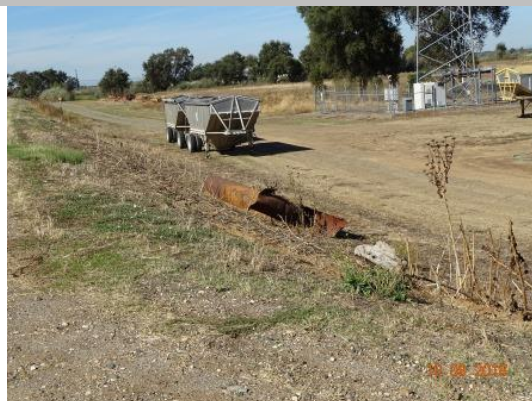
Photo 1 of 2 : FA\_2018\_RD1001\_40\_24\_20181114\_00041.jpg

LM Start	4.71	Rating **	M	Issue No.	24
LM End	4.71	Issue Type +	Ma	Location *	LS
Category	Earthen Levee			GPS Latitude/Longitude	
				Start	End
Item	Encroachments			38.896310 °	38.896310 °
				-121.520674 °	-121.520674 °
DWR ID	DWR_RD1001_06_f_2016_24				
Comment Code					
DE : Debris					
Inspector Comment					
Old peace of pipe still lying on landside levee slope, Fall 2018.

View of an old piece of pipe still lying on landside levee slope looking downstream. Fall 2018.
